The impact of the 2011 Tohoku earthquake tsunami disaster; implications to the recovery and reconstruction

Shunichi Koshimura

International Research Institute of
Disaster Science (IRIDeS)

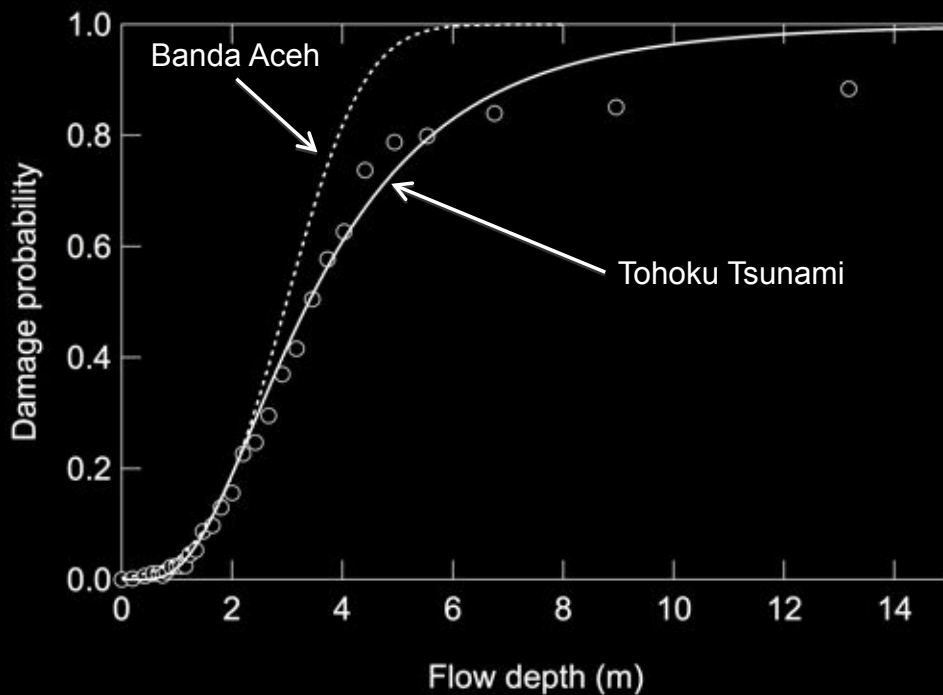
Structural vulnerability Tohoku & Banda Aceh

2 m tsunami flow depth potentially causes severe damage on houses or may devastate.

Over 6 m tsunami flow depth will cause total devastation.

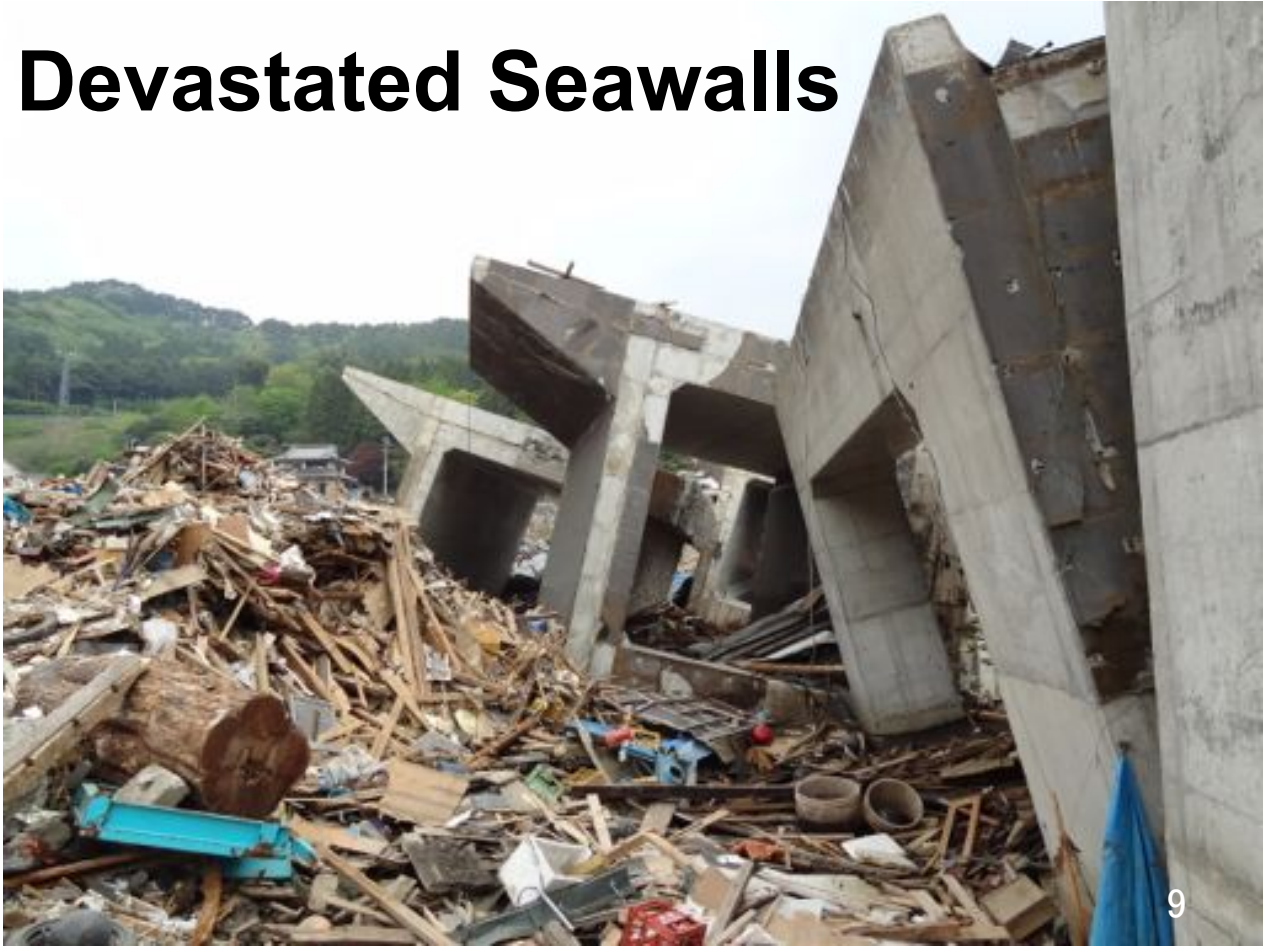
Devastated Seawalls

Breakwaters and seawalls can NOT always protect our lives and properties. It's design should assume overtopping and resiliency.

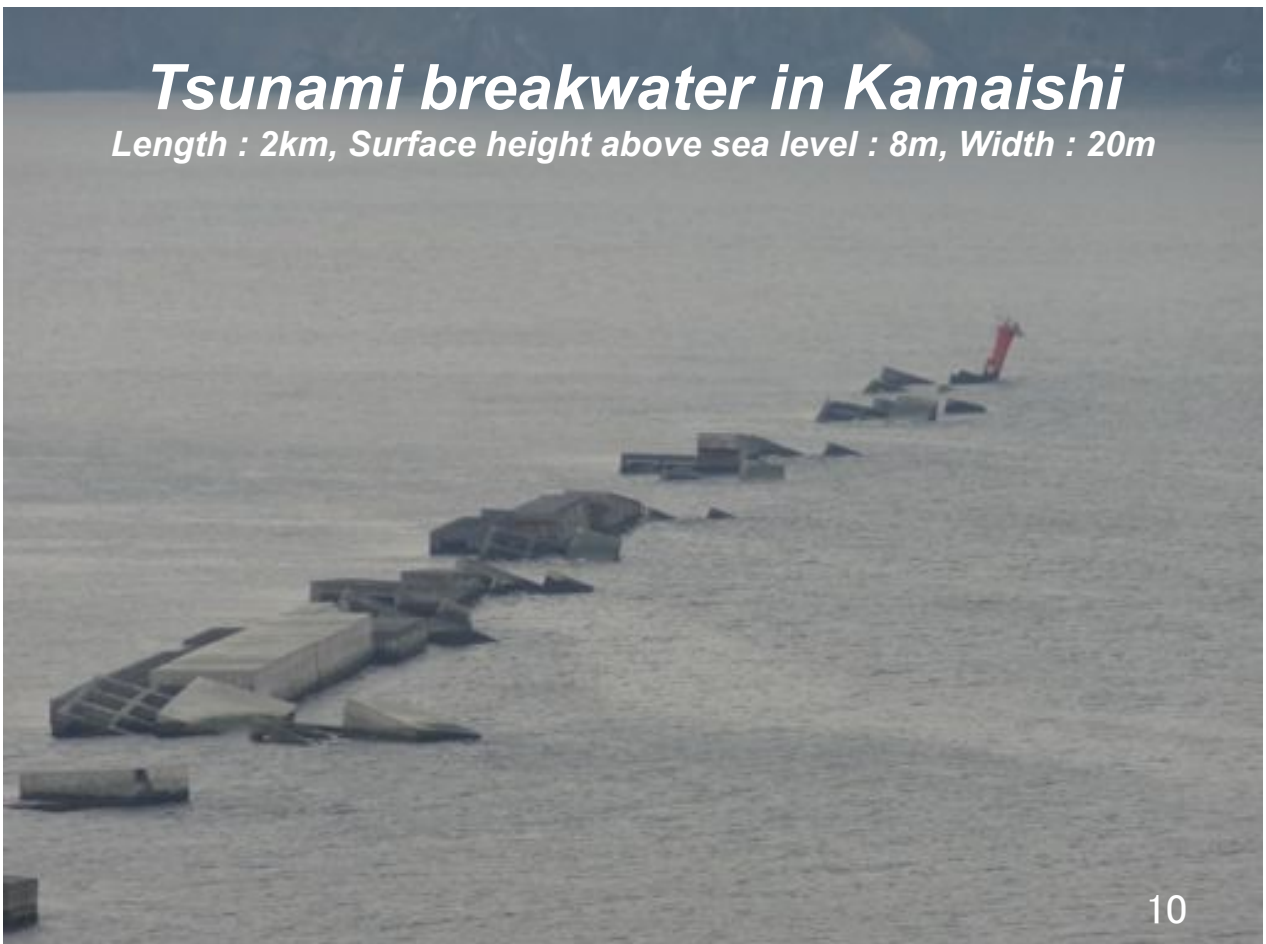
Tsunami breakwater in Kamaishi
Length : 2km, Surface height above sea level : 8m, Width : 20m

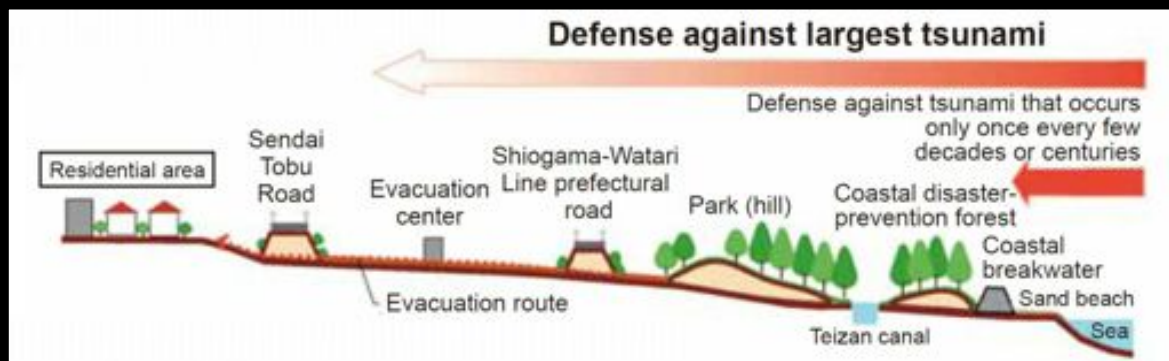
Sendai city's reconstruction plan Multiple protection to minimize losses

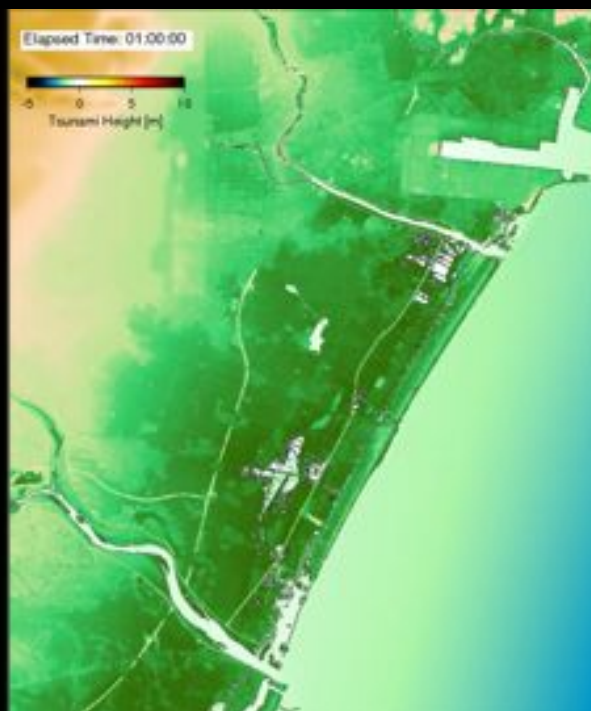
How the multiple protection works ...

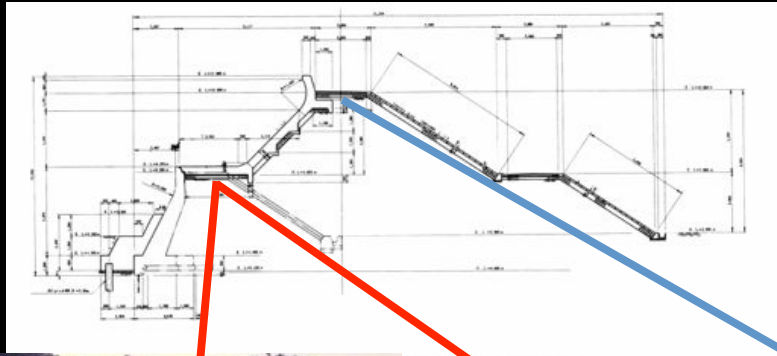
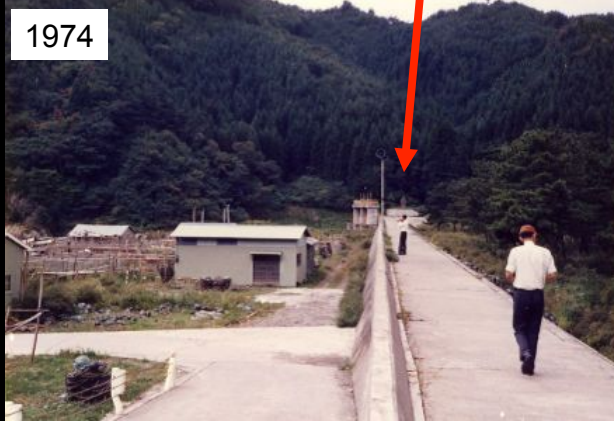
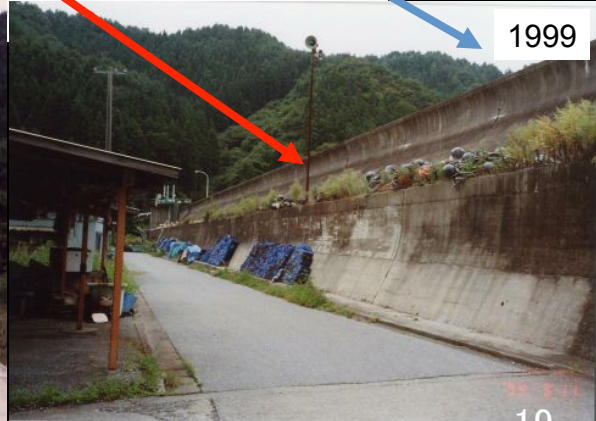
The sea wall was build in 1974 and 1999

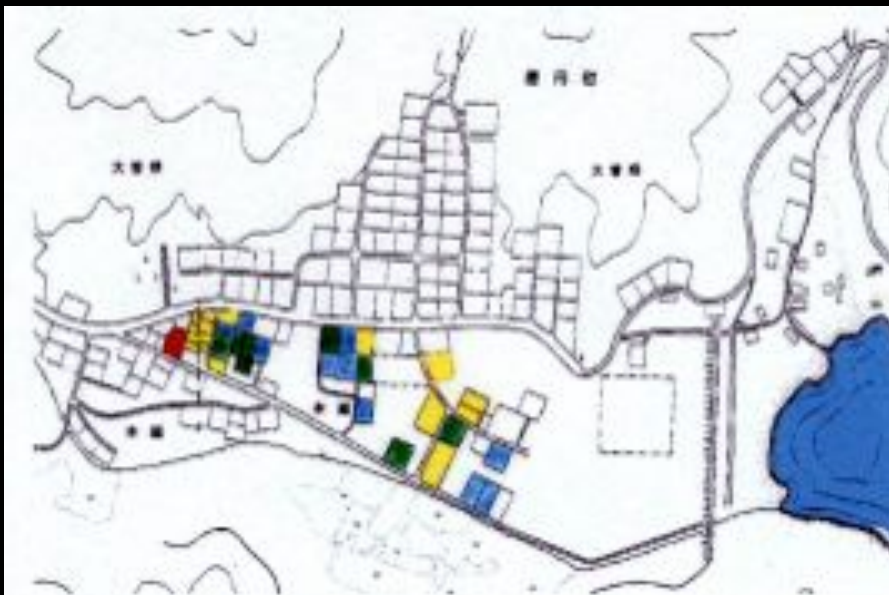
After the sea wall was built...

- Before 1960
- Until 1974
- Until 1999

Building sea walls does not always contribute to increasing tsunami-resiliency (resilient and sustainable community).
